Manhole Inspection Summary

Manhole # S11II_001MH

Location Address: **REAR 1801 ROSEDALE ST**

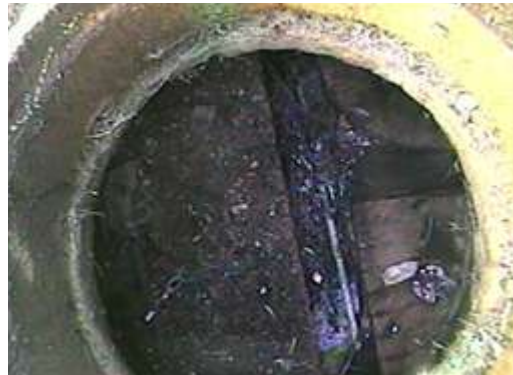
Top View

Condition: ☐ Sound ☐ Cracked ☐ Root Intrusion ☐ Loose Brick ☒ **Deteriorated**

Condition: ☐ Sound ☐ Cracked ☒ **Root Intrusion** ☐ Loose Brick ☐ Deteriorated

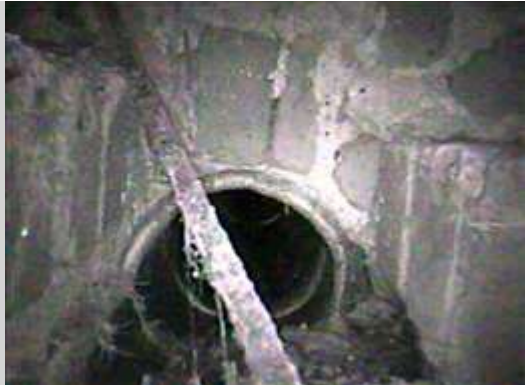
12 O'Clock Outflow

6 in. Circular Gravity Sewer
Pipe Out @ 12 O'Clock

Pipe Height: (in.) Direct
Pipe Material: **Clay** ☐ Pipe Lined
Invert Depth: **4.41** (ft.) Flow Characteristics: **None**
Deposits: ☒ None ☐ Mud ☐ Sludge ☐ **Debris** ☐ Grease
Silt Depth: (in.) Deposits Extent:
Infiltration: **None** Pipe Seal Cond: **Sound**

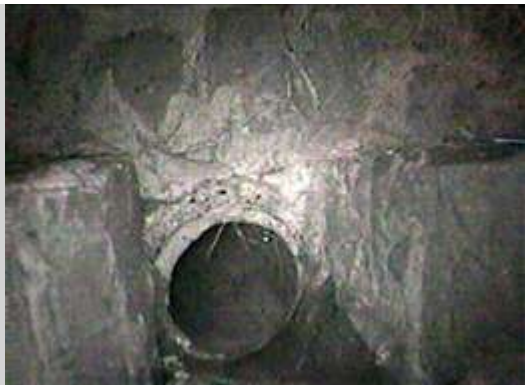
3 O'Clock Inflow

4 in. Circular Gravity Sewer
Pipe In @ 3 O'Clock

Pipe Height: (in.) Direct
Pipe Material: **Clay** ☐ Pipe Lined
Invert Depth: **4.42** (ft.) Flow Characteristics: **None**
Deposits: ☒ None ☐ Mud ☐ Sludge ☐ **Debris** ☐ Grease
Silt Depth: (in.) Deposits Extent:
Infiltration: **None** Pipe Seal Cond: **Sound**
